MEMORANDUM

SUBJECT: Hunters Point Building 364 Removal Action Findings

Building 364 Removal Actions:

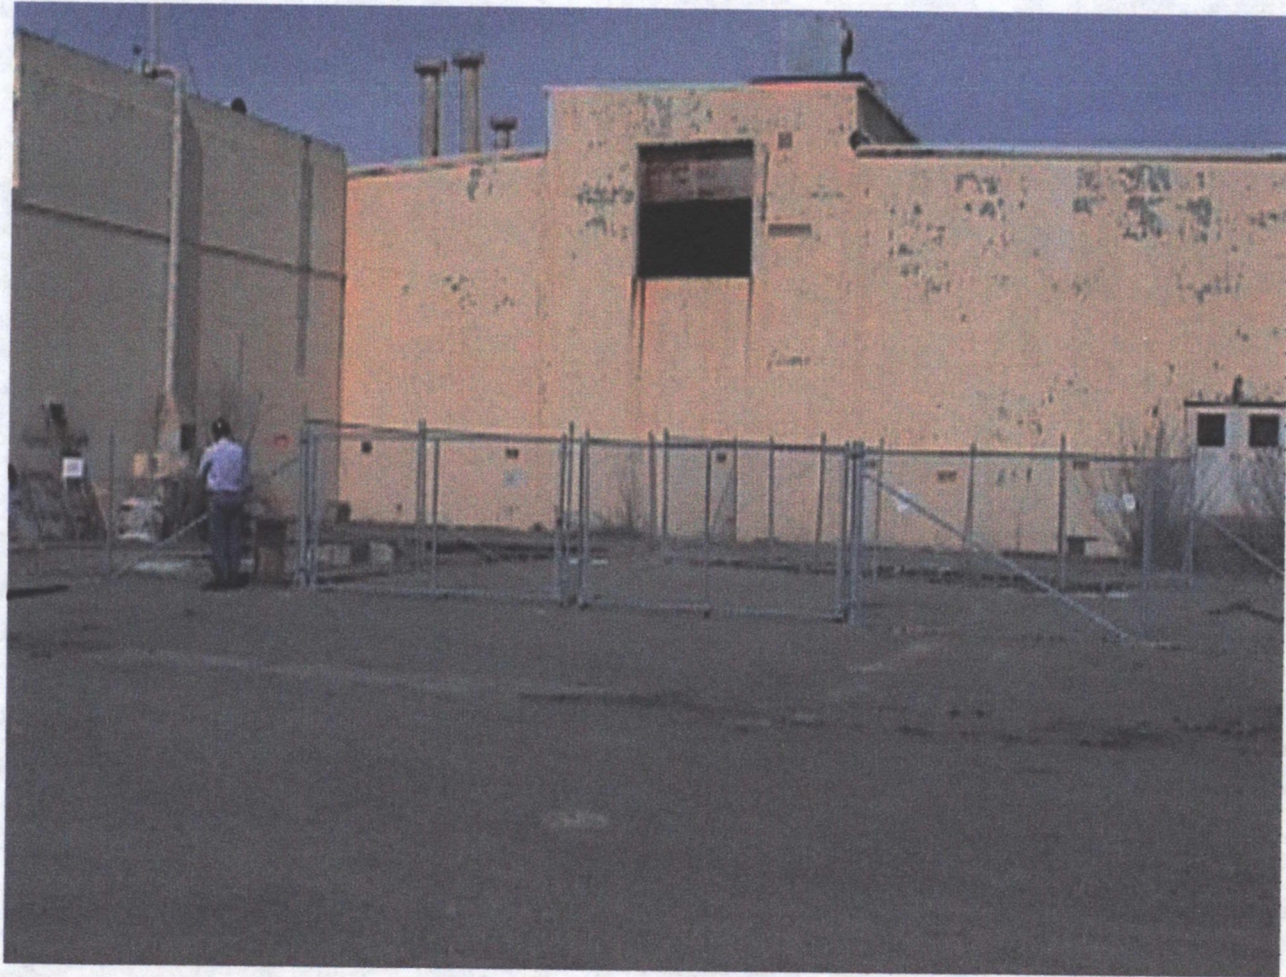
Building 364 Removal Action

First, I evaluated the results of radiological contamination removal actions conducted by the Navy and its contractors at HPNS behind Building 364. The removals were conducted in two areas; the radioactive waste storage sump and a cesium-137 (Cs137) surface spill commonly referred to as the "peanut spill" because to its outline is peanut shaped on the asphalt's surface.

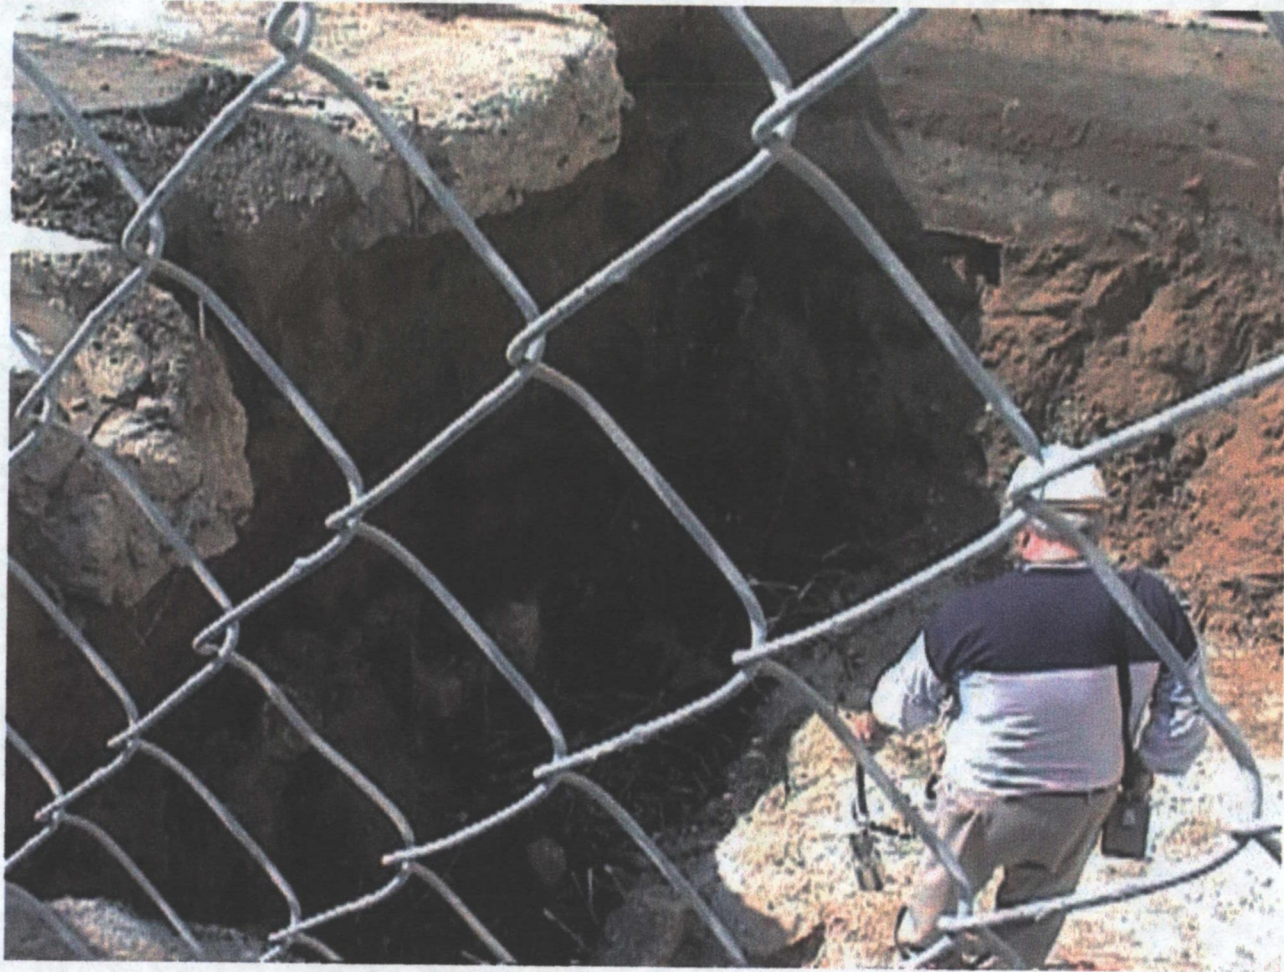
B364 Sump Pit Gamma Survey

I performed a gross gamma ray survey using a Ludum 2221 rate meter with a 3" x 3" Sodium Iodide gamma probe. I did not find any areas that exhibited gamma anomalies. While all readings were consistent with background, I chose two locations that gave the highest gross gamma readings and performed gamma spectrum analysis on each location. I used an Exploranium GR-130 Spectrum Analyzer to acquire the gamma spectrum data.

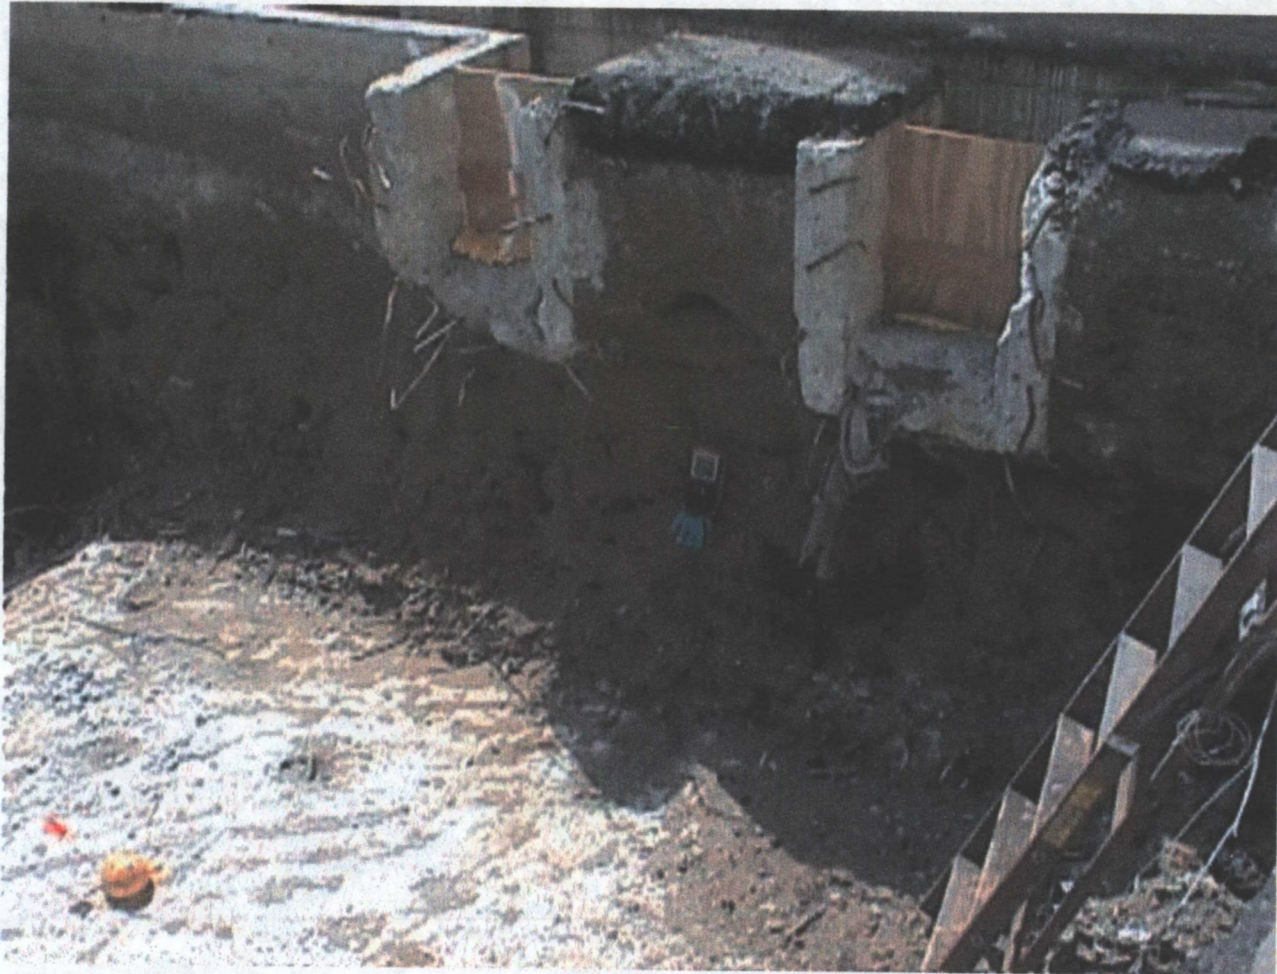
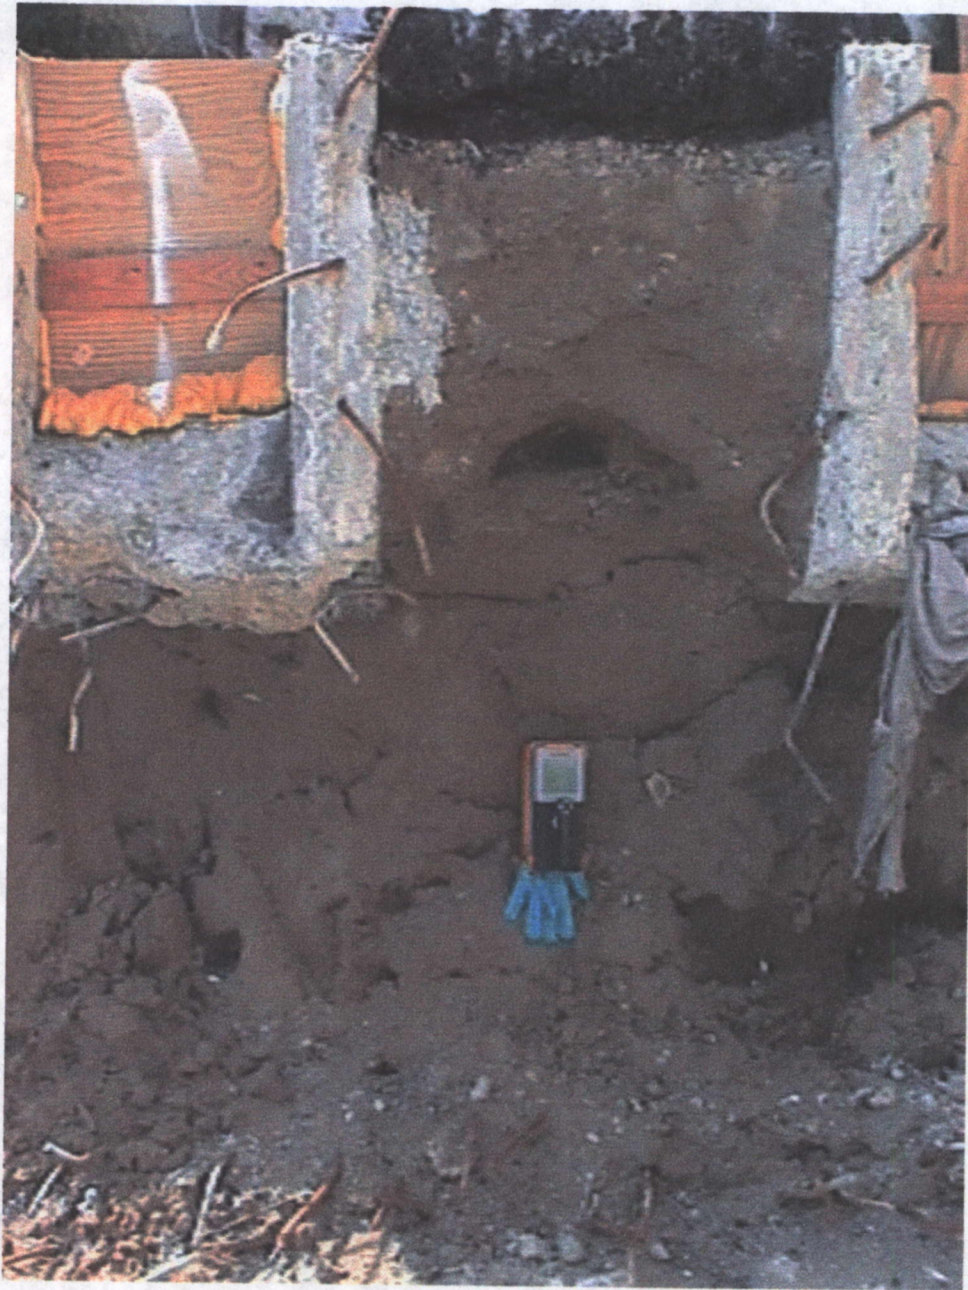
Sump Removal Pit Wall Spectrum Analysis

While this area exhibited the highest gross gamma reading in the pit, the gamma spectrum shows that no gamma emitting radioactive contaminant is present. The elevated background was from the configuration of the wall's undercutting and nearby concrete structures which changed the counting geometry and thus increased the probe's detection efficiency. This translates into a slightly higher peak in the Compton scatter region, from zero to about 400 kilo-electron-volts (kev), of the spectrum. With this one exception, the wall's spectrum compares well to a background spectrum taken on unimpacted asphalt near Building 364. No Radium-226 (Ra226), Cs-137, or other radionuclide contaminants of concern are present in the spectrum.

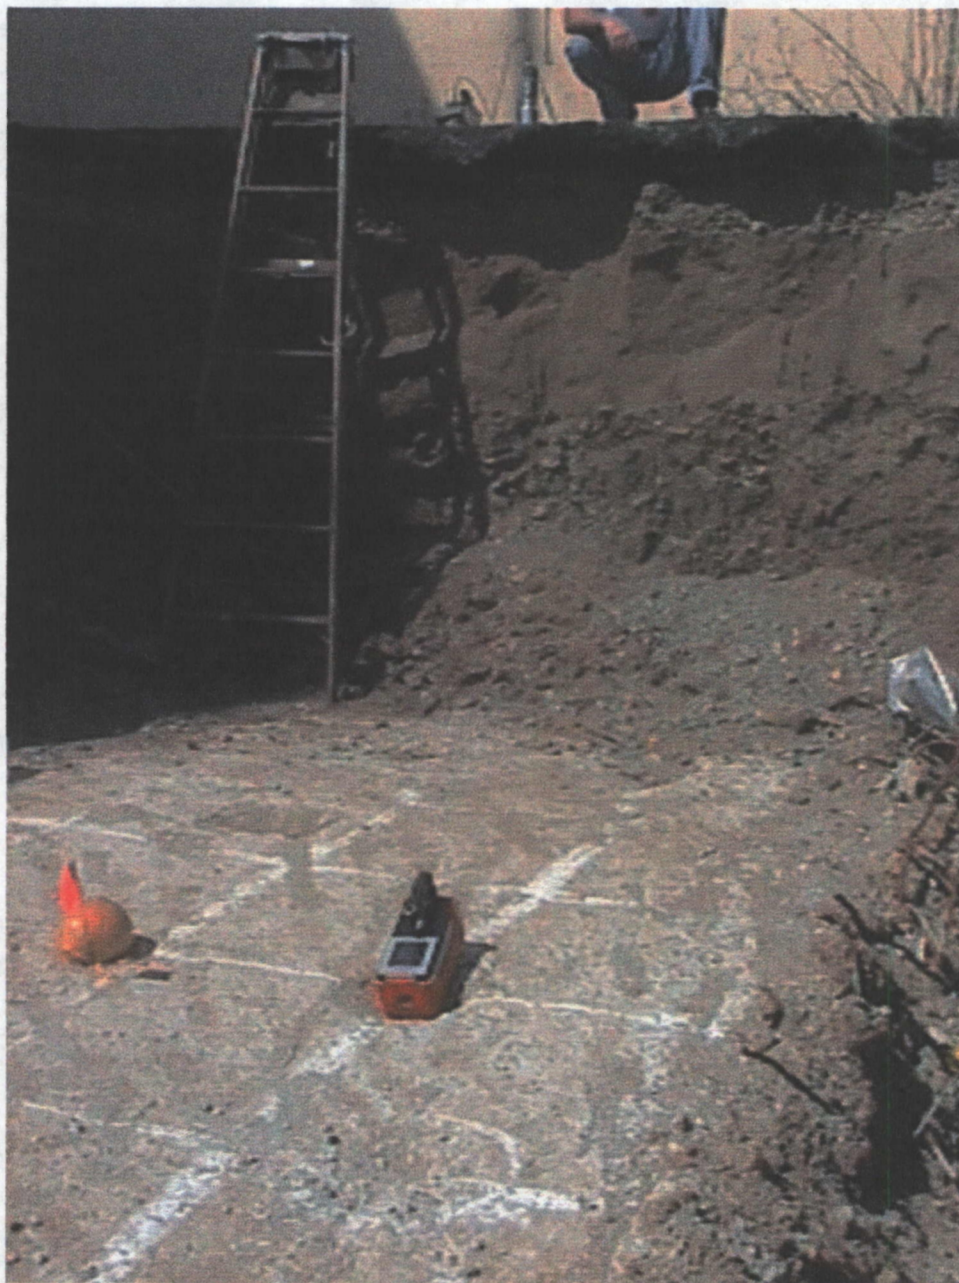
Sump Removal Pit Floor Spectrum Analysis

One small indentation in the concrete floor had slightly higher gamma counts. The

indentation was made by workers while removing a small area of fixed contamination on the concrete floor. The spectrum of this area revealed no evidence of any residual radioactive contamination.

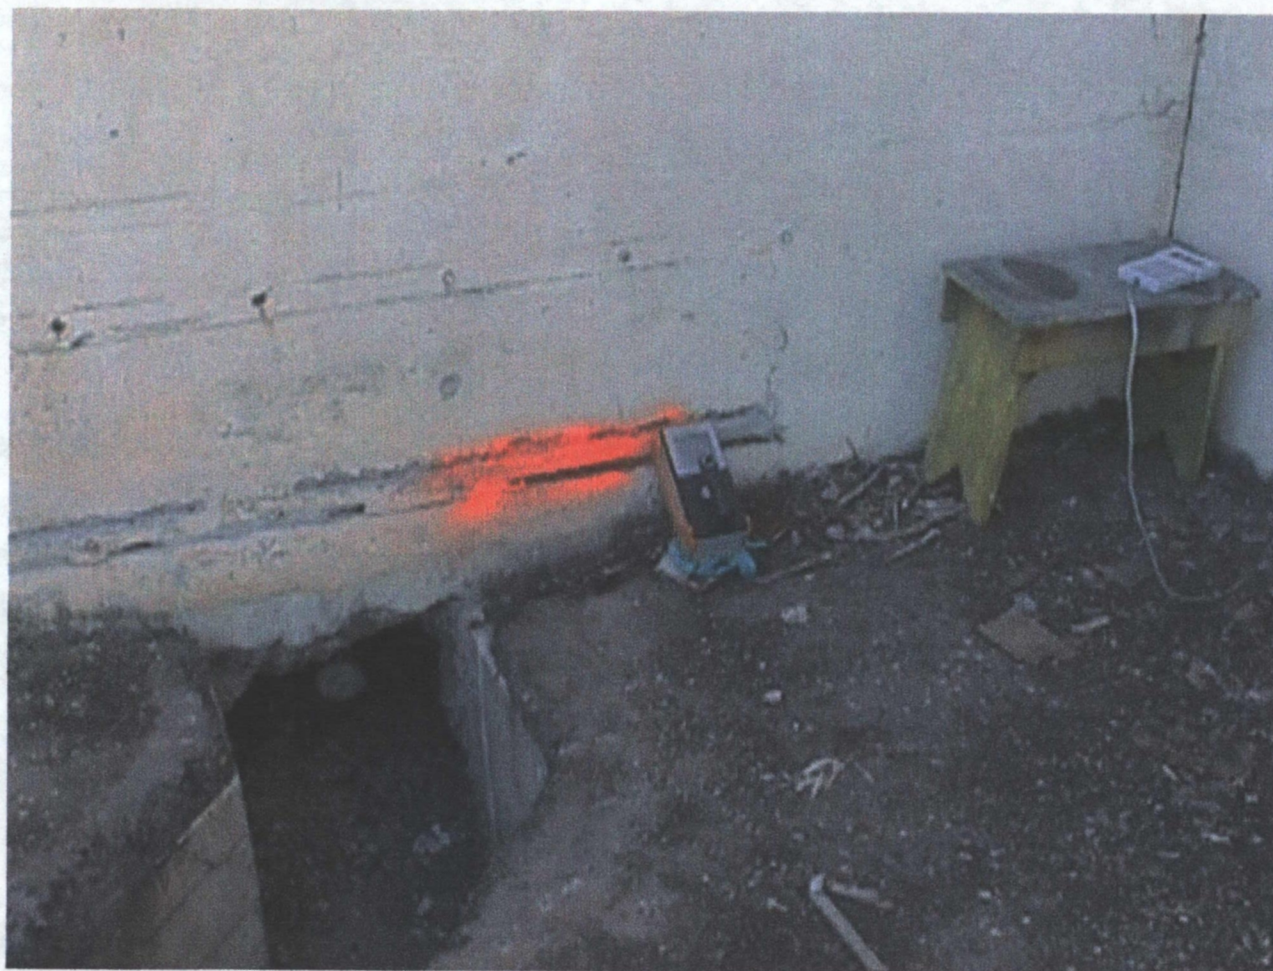
B364 Vent Wall Spectrum Analysis

A spectral analysis of the exterior wall of Building 364 exhibited conclusive evidence that considerable Cs137 contamination is present. The Cs137 is localized in a seam between the original wall and a concrete patch that was applied to an old ventilator duct that passed through the exterior wall. This area requires remediation.

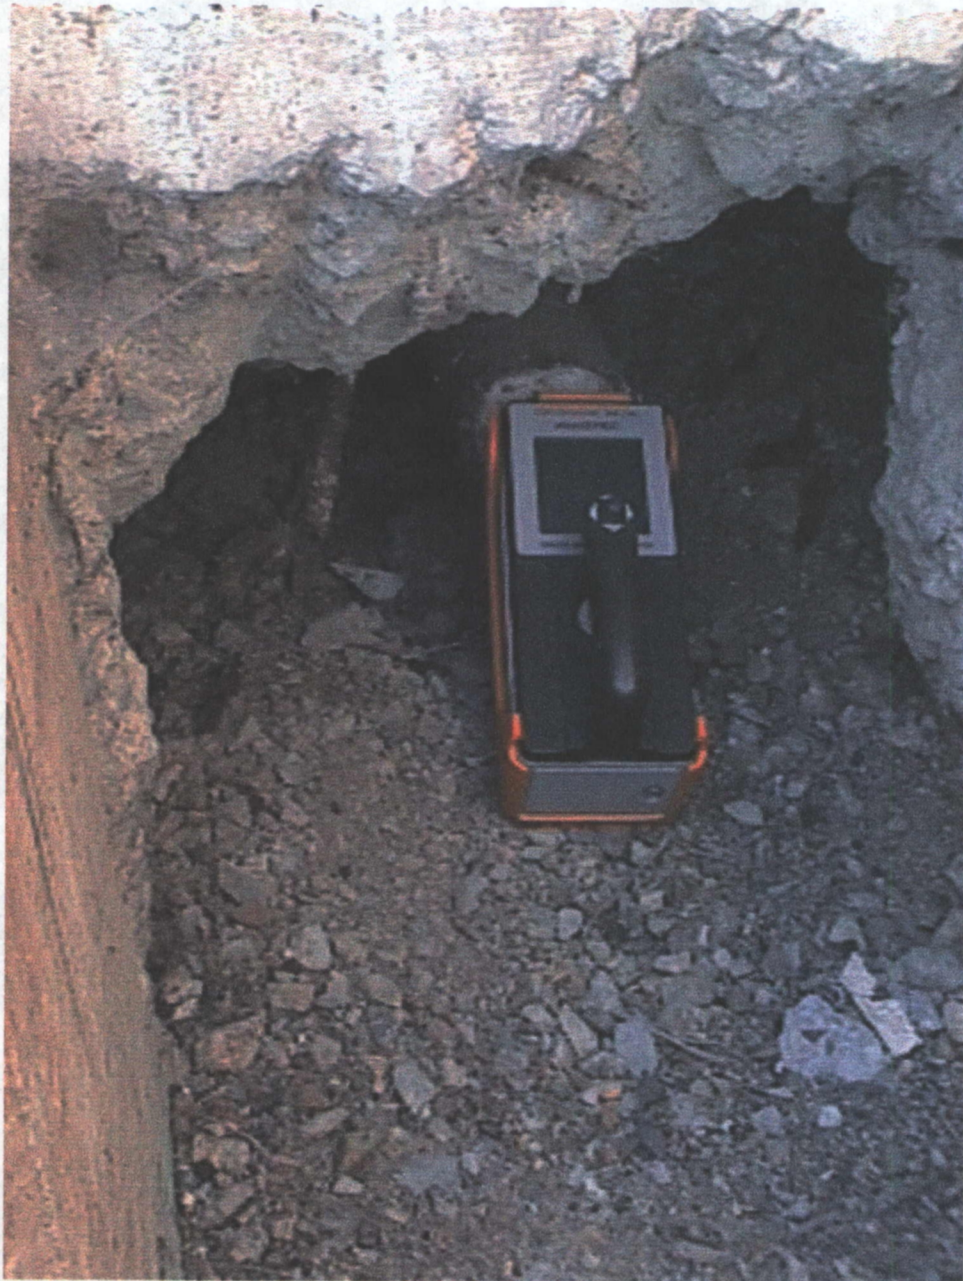
B364 Drain Pipe Spectrum Analysis

A concrete fill iron drain pipe is located under the building just below the ventilator duct area. The pipe also exhibited considerable Cs137 contamination which was confirmed by the spectrum data. A spectrum peak at around 662 kev indicates the presence of Cs137. This pipe should be removed for radiation waste disposal.

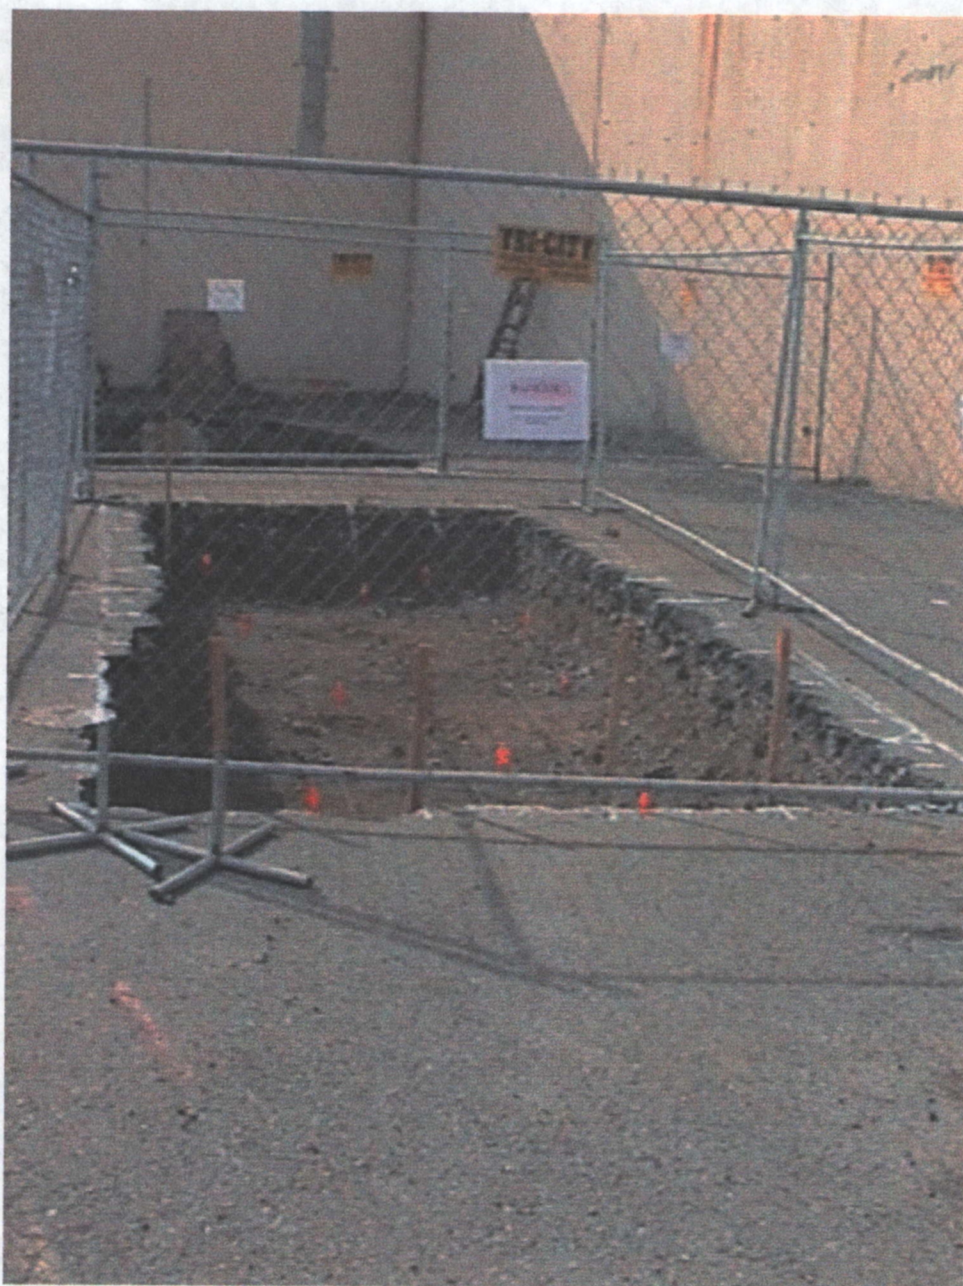
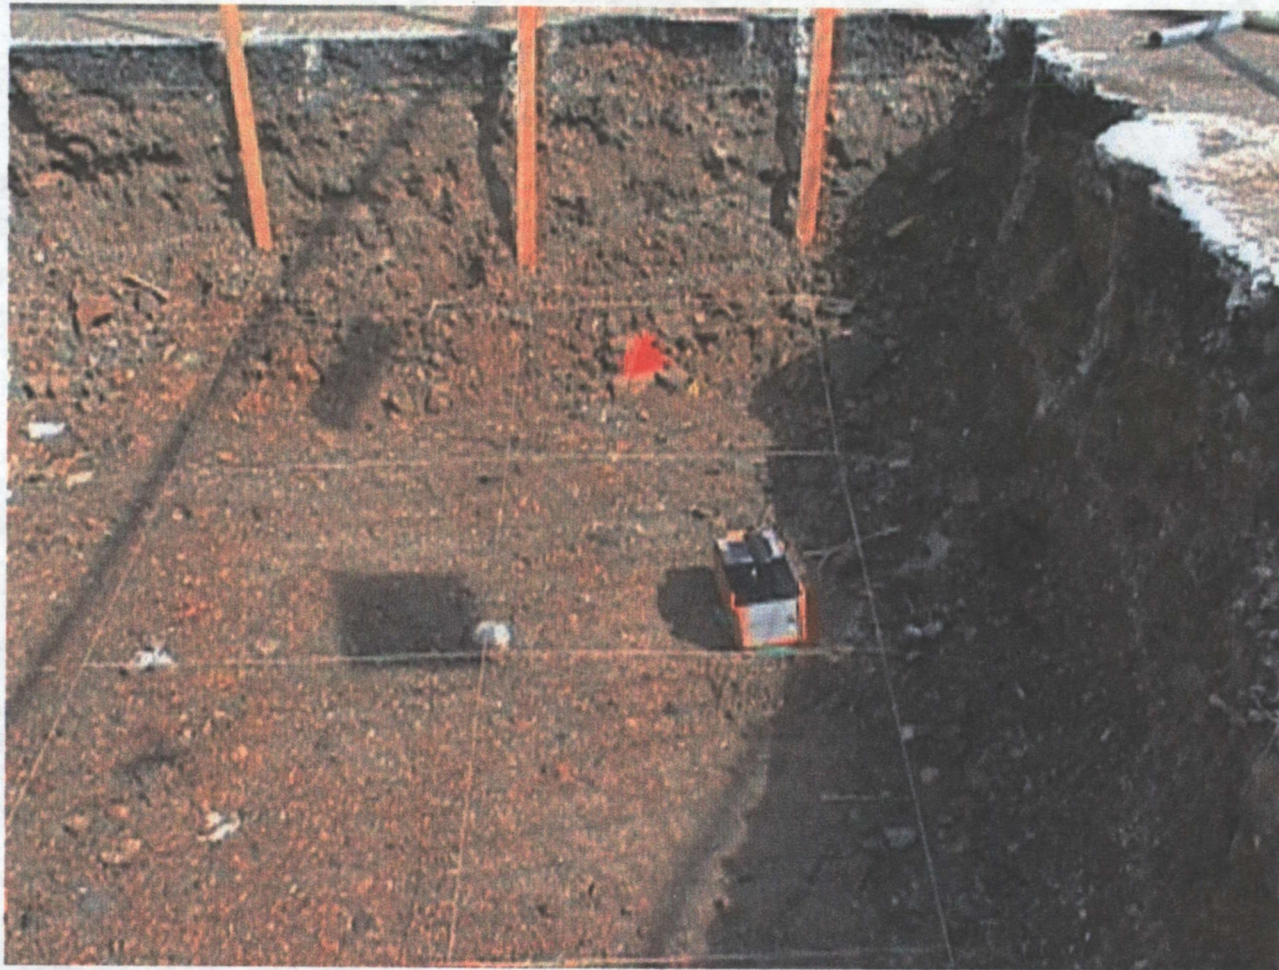
Peanut Spill Removal Pit

My gross gamma survey did not reveal any leveled gamma areas. So, I chose, as closely as I could recall, the region in the spill where the last Cs137 hit had been detected by the GR-130. The spectrum data did not reveal the presence of cesium or any other radionuclide contaminant.

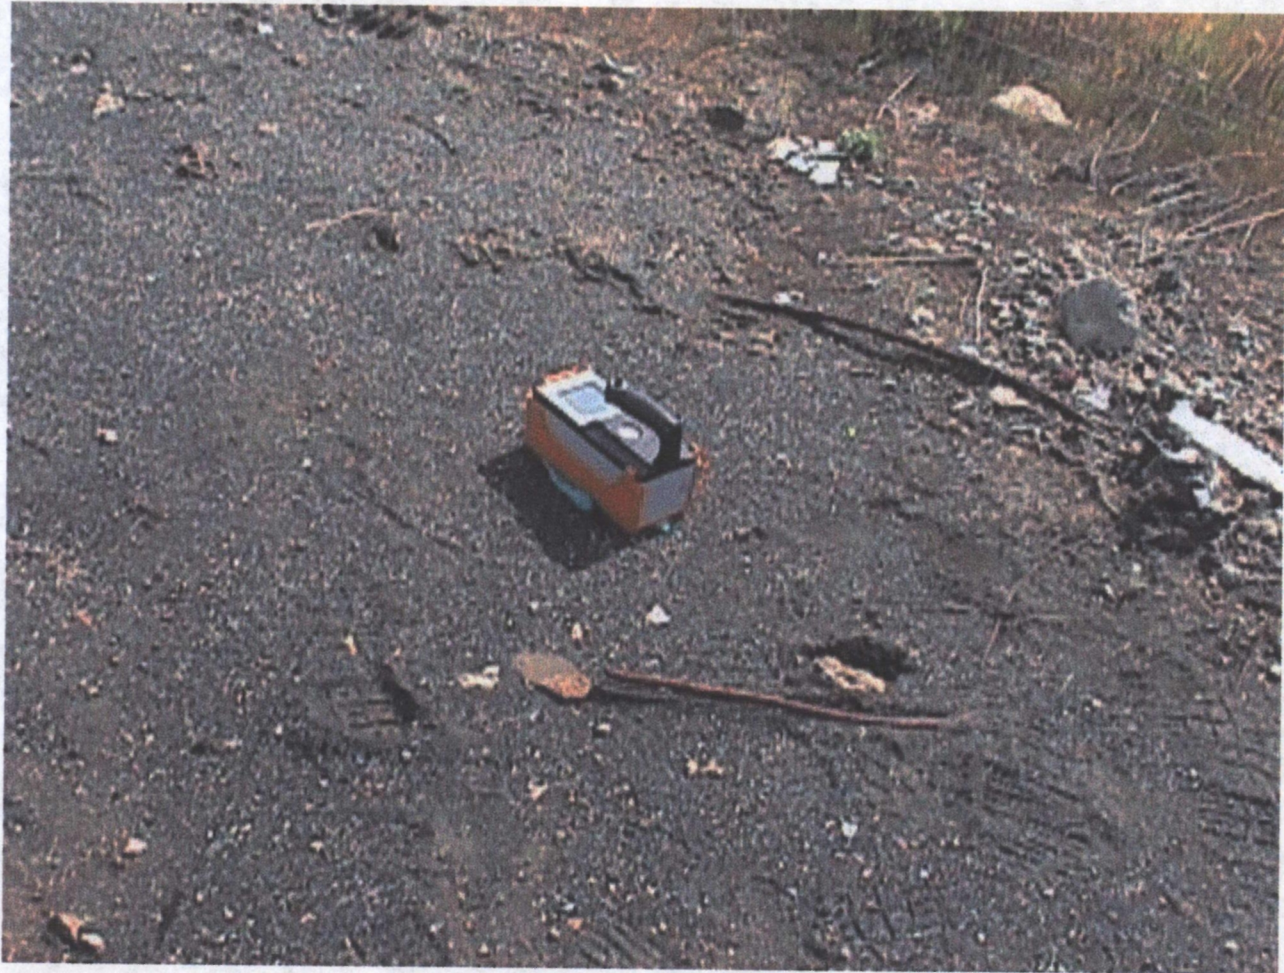
Black Beauty Sandblast Grit

I analyzed an area in Parcel E impacted by black beauty sandblast grit to determine whether or not this material meets the requirements for removal as a radium-226 waste material. The spectrum on very close scrutiny does reveal a slightly elevated peak at 352 kev, a region associated with lead-214 (Pb214) which is a radium decay daughter. The Navy has agreed to remove and dispose of the sandblast grit even though the radium concentration in the grit may not require it.
